Welsh Color & Conservation, Inc.
Analysis of Historic Paints and Wallpapers

MICROSCOPICAL PAINT AND COLOR ANALYSIS

PROJECT INFORMATION	CLIENT INFORMATION
Name: Tovar House Location: 22 St. Francis Street St. Augustine, Florida Construction Date: ca. 18 th & 19 th century Style: 2 ½ story Spanish/British Colonial Owner: St. Augustine Historical Society	Name: Susan R. Parker, Ph.D. Company: St. Augustine Historical Society Address: 271 Charlotte Street St. Augustine, Florida Phone: 904-824-2872 Email: sahsdirector@bellsouth.net
<i>Today's Date: 7/8/2013</i>	
DESCRIPTION OF PROJECT	
<p>The Tovar House, so named after its original builder and owner, was constructed in the very early 1700's as a small two story home. Since then it has had multiple owners and occupants, all of whom contributed to its lengthy and complex history of additions and alterations, even up to the present. This history has been researched by several contributors over time, but most recently by Herschel E. Shepard, FAIA. His efforts have contributed significantly to the determinations of this paint analysis project, and vice versa, making both an excellent team endeavor in attempting to ascertain, as best we can

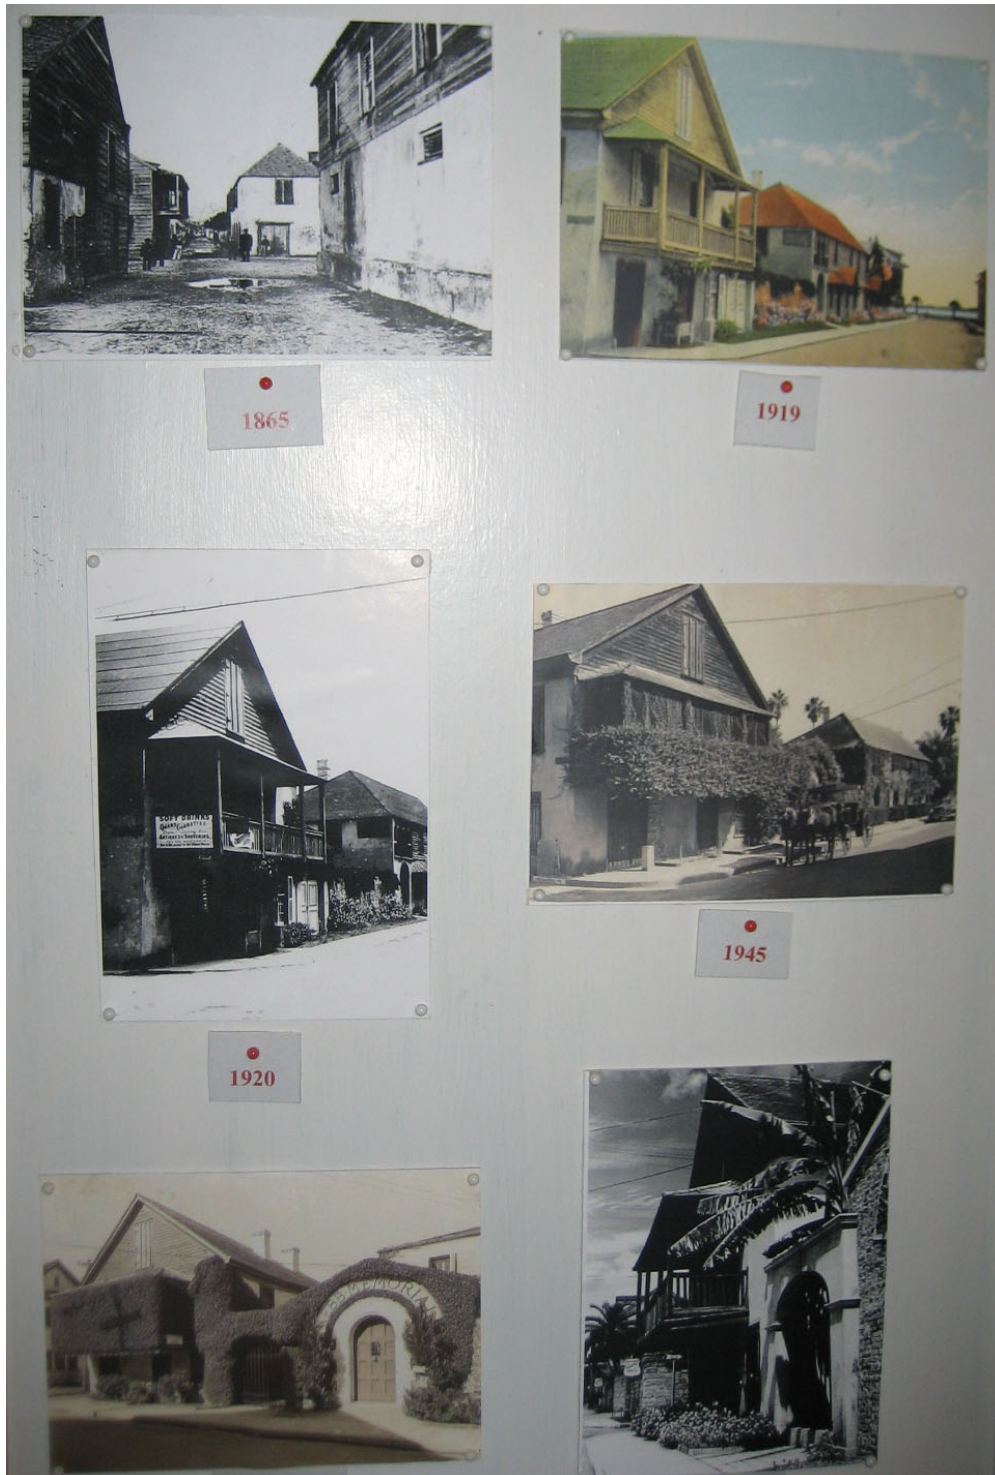
The image below, from the display board developed by the museum, presents a series of historic images of the Tovar House along with the dates associated with each one. The most striking change in the architectural evolution of the house, as depicted in these images, is between those from 1864/65 and that of from 1919. This major alteration, which took place in the mid-to-late 1800's is the principle period of significance for the efforts of this report.

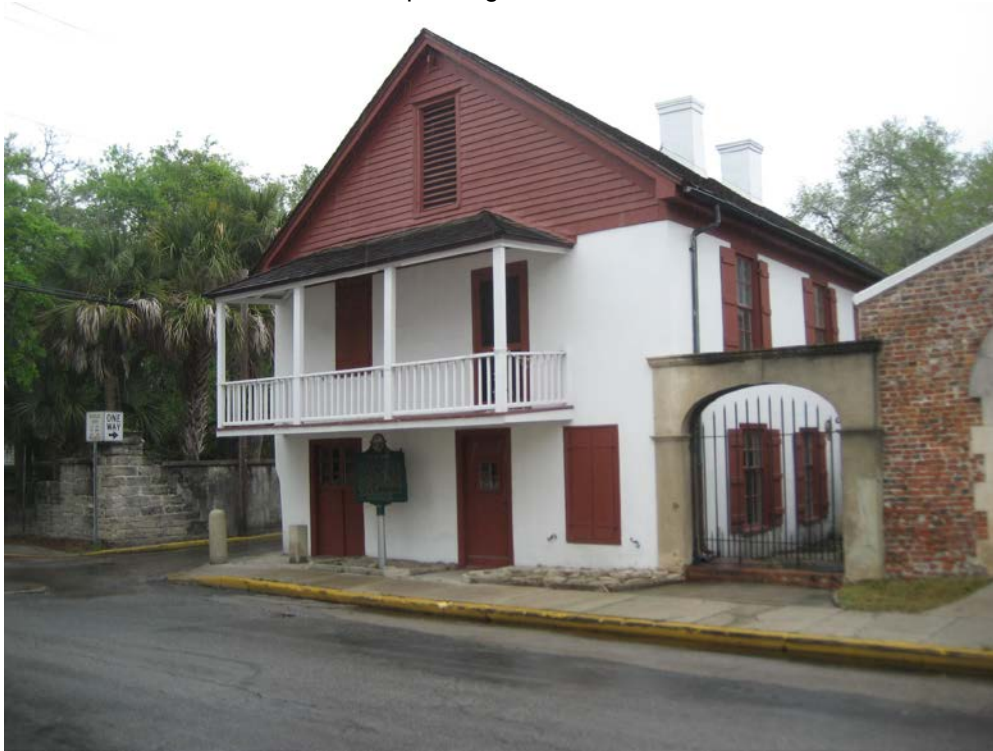
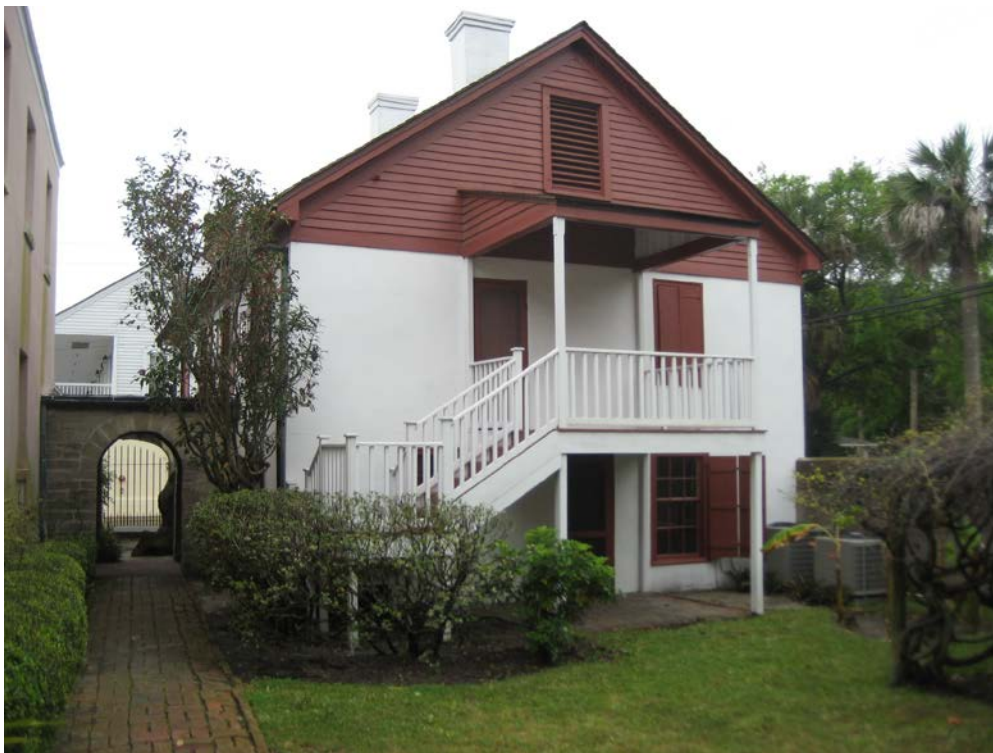
The images below show the Tovar House as it appeared in the spring of 2013 following repairs, renovations and repainting of the interior and exterior.

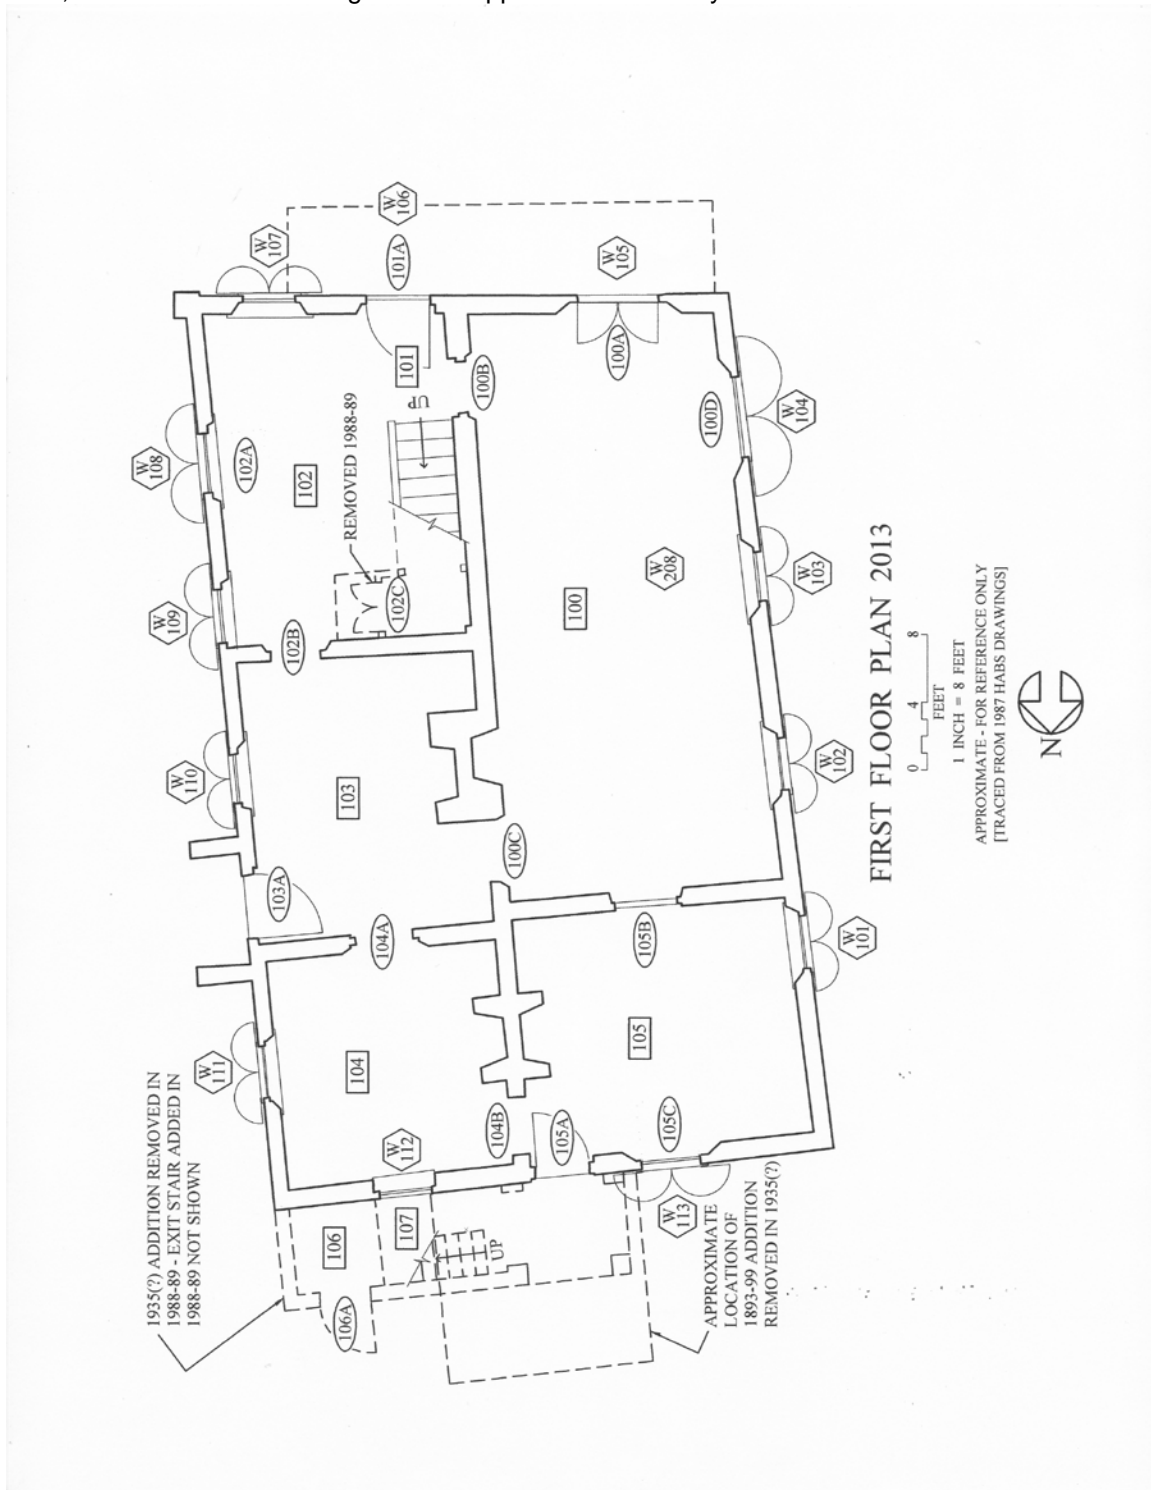
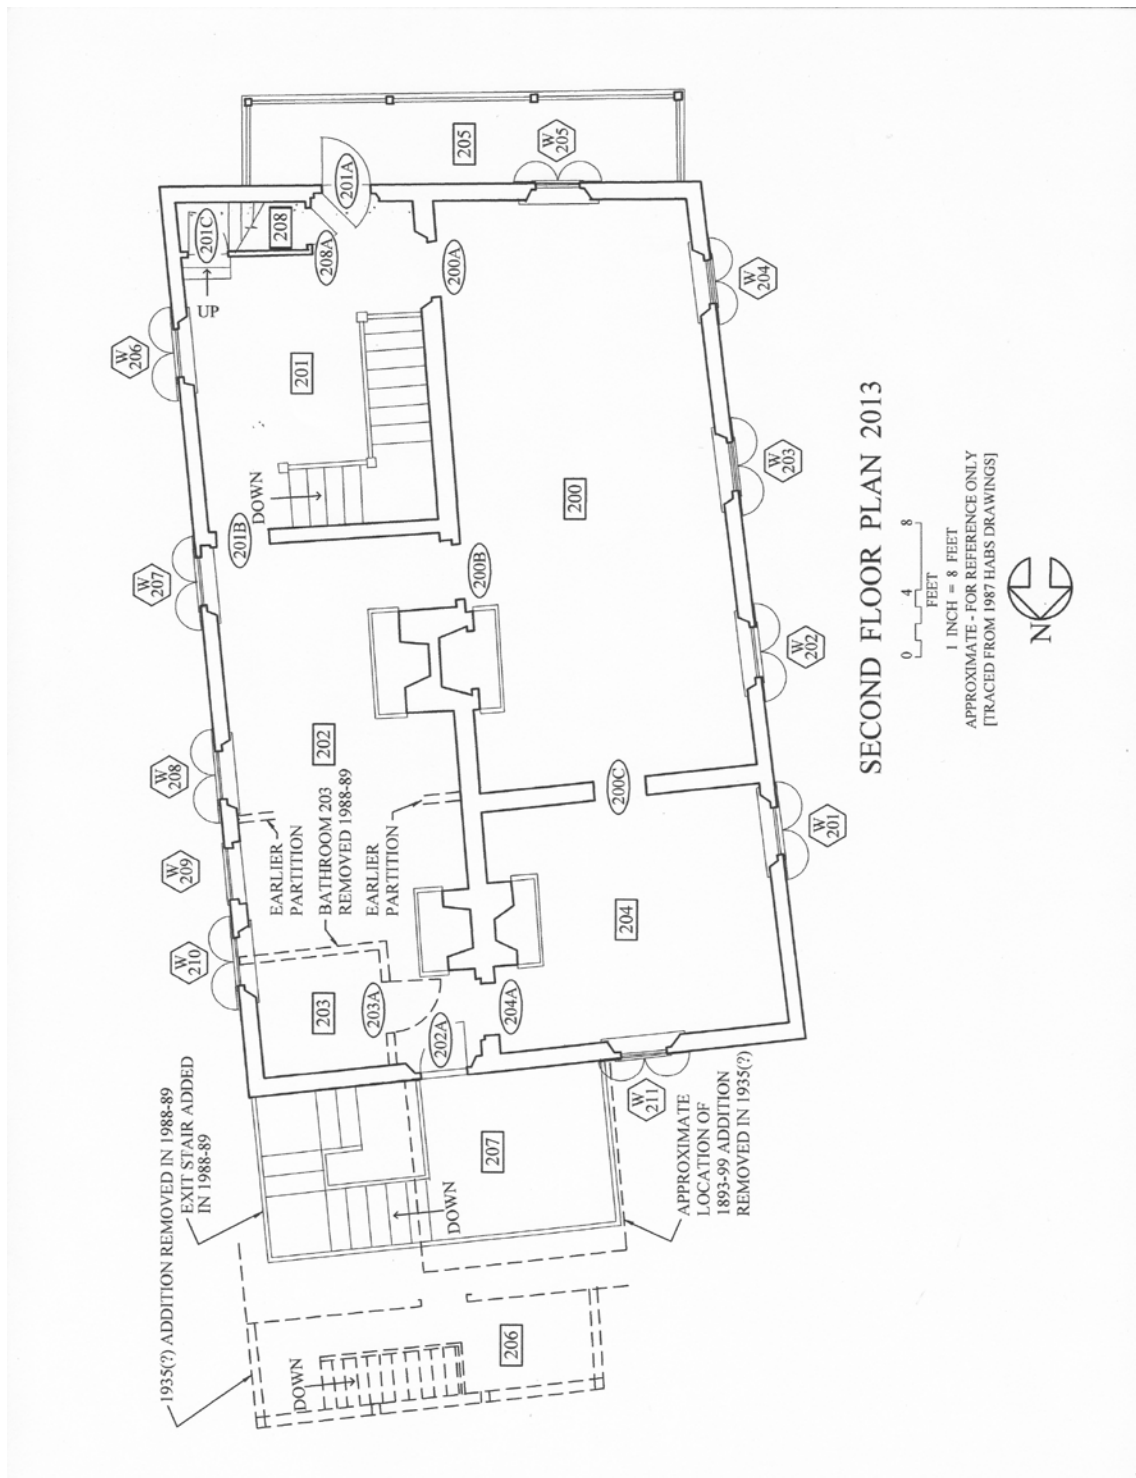
The first and second floor plans on this page and the next (developed by HES) show the room configurations as they exist today. The room numbers, as well as the associated door and window numbers, are used in the following text and appended Laboratory Data Sheets.

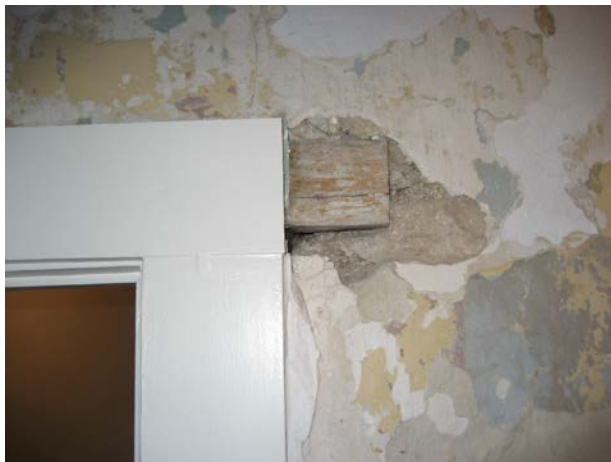
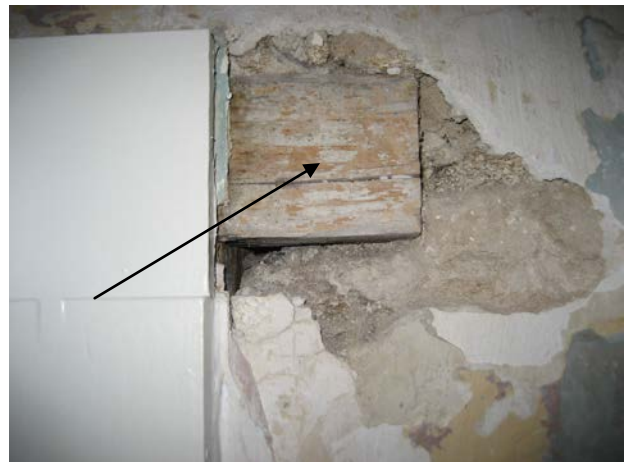
The oldest wall finish on the second floor was found on a buried header, behind old plaster on the Room 200 side of doorway 200-B. This old wood header had one layer of white whitewash on it. The plaster that covered it along with the rest of this walls' plaster shows numerous layers of white whitewash.

Room 200, Doorway 200-B, upper right side of frame showing exposure of original header after removal of old plaster that covered it. The wood header shows one layer of very old white whitewash.

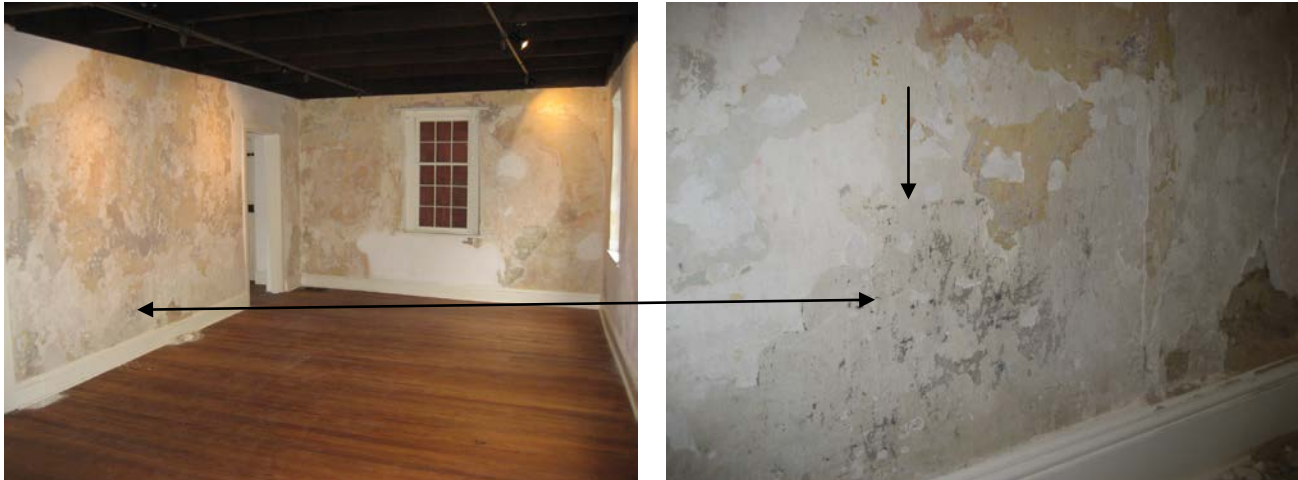
In addition to the numerous layers of white whitewash on the old plaster walls there is very good evidence a very low-painted wainscot throughout this room (Room 200). At some time in the 19th century, probably middle years, a black paint was applied to the lower portion of the walls. The top of this black paint did not exceed a height of 20" measured from the flooring. This black wainscot was painted on several times. The black painted wainscot in this room is reminiscent of the black paint on the wainscot of the second floor large room at the Ximenez-Fatio House. My analysis of the black paints there suggests a mid-to-late 19th century date.

Room 200, Arrows point to vestiges of a ca. mid-19th c. black painted wainscot that extended up to 20" from floor.

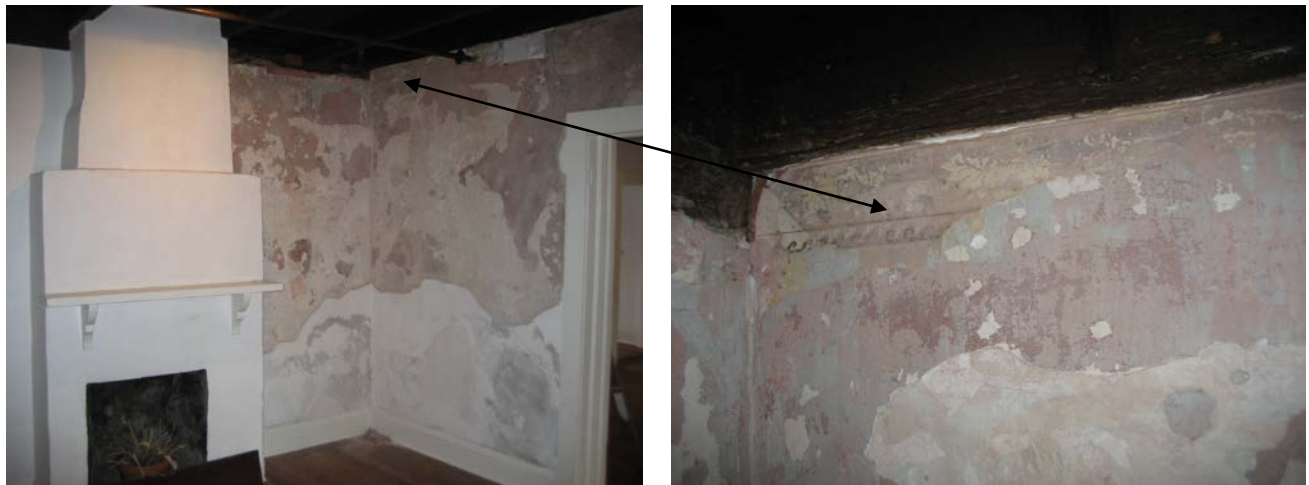
In the later part of the 19th century, wallpapers were used in the house. Wallpaper fragments were found in Rooms 202 and 204. The evidence in Room 204 was extensive. A long run of a wallpaper border with pattern survives along the south and east walls of this small room. All of the wallpapers and fragments are made with wood pulp papers. The wood pulp paper was not commercially available before the 1860's. The fragments that survive could be from the Hardin period and/or later.

Room 204, south east corner, large fragments of a c. late 19th c. wallpaper border that was recently revealed when the walls were scraped, thus removing later paints and skim coats of plaster.

Also, priority should be given to the preservation of the wall paper evidence found in the second floor rooms.

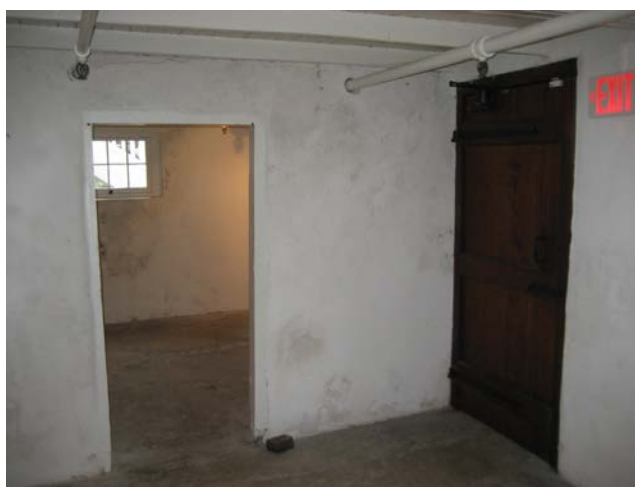
Room 103 looking at doorway 104-A

The earliest wood trim features are doorways 104-A and 105-B. Both show debatable evidence of dirt on the wood surface that suggests the wood was not painted originally. The wood itself in each feature is dark, unlike the lighter colored woods associated with every other wood feature sampled. The first paint finish on these two features is a moderate reddish brown, oil paint that was made with red iron oxide pigment. There is evidence of dirt on this paint that suggests it was exposed as a finish for a number of years. There is a second finish paint layer of the same color, a moderate reddish brown. This second layer; however, is associated with the mid-to-late 19th century as indicated below. The samples taken from these two doorways are associated with the rooms they connect.

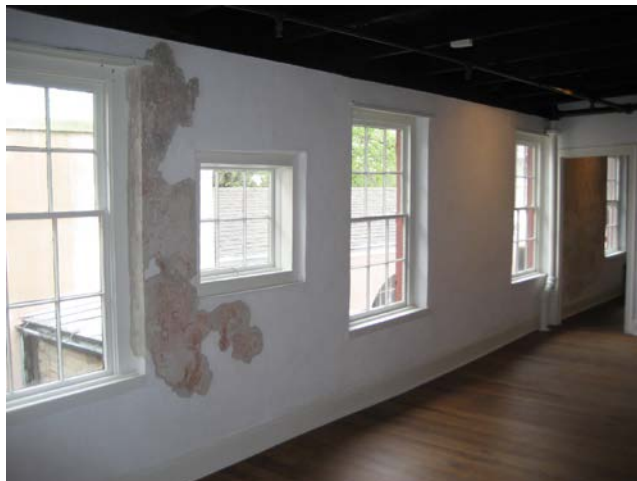
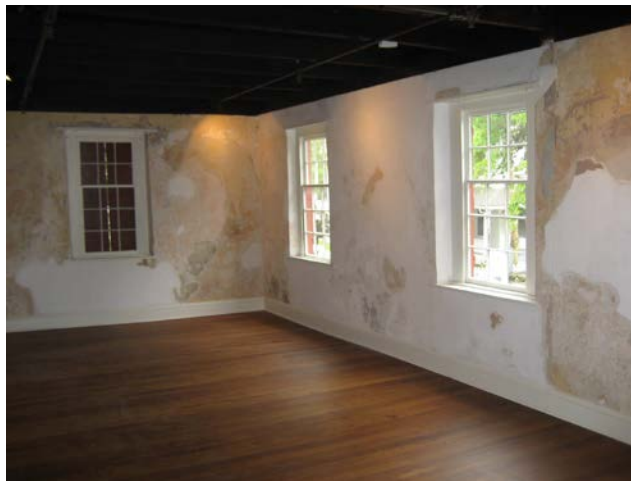
The oldest window frames, heads and sills are contemporary. They were painted originally with two different colors. The frames were painted with a moderate reddish brown, oil paint made with red iron oxide. Both the head boards and the sills were painted with a moderate blue, oil paint made primarily with zinc oxide (zinc white) and Prussian blue pigments. Many samples were taken from the tops of the frames just below the window heads. These samples often showed a splash over of the medium blue onto the moderate reddish brown, indicating they are contemporary with each other. The use of zinc white in the medium blue paint is useful for dating the paints. Zinc white was not commercially available before the 1850's. Many doorways and doors also show the same moderate reddish brown that is on these mid-to-late 19th century windows as the first paint finish. Several windows appear to be just about as old, but there is no moderate reddish brown paint on them. One is window W 208. Refer to the appended Laboratory Data Sheets to see which windows and doorways have these mid-to-late 19th century finishes. Most are on the second floor.

Most windows and some doorways date to the mid-to-late 19th c. Most are on the second floor. Those that are show the polychrome scheme of moderate reddish brown on the frames with medium blue on the head boards and sills. The color of the window sashes at this time is unknown since the existing 19th c. sashes are slightly later than the frames.

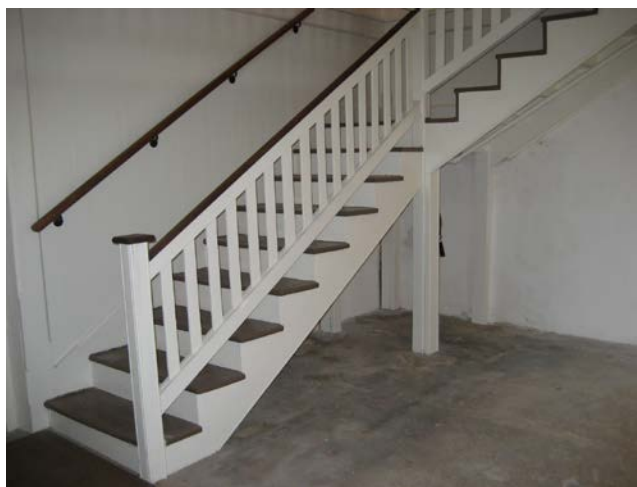
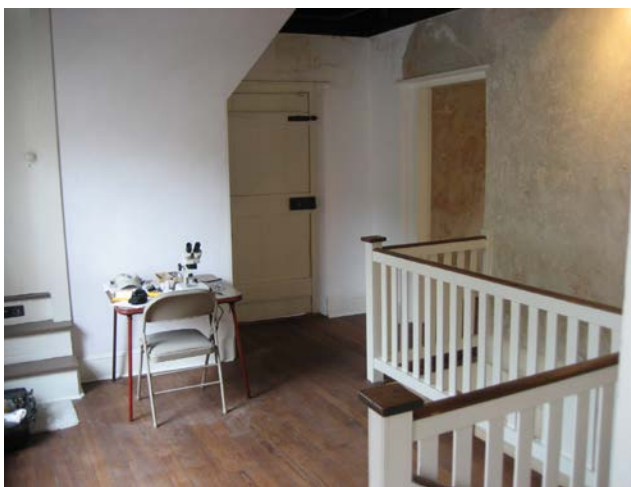
In addition to the windows and some doorways, the staircase fascia boards and the balustrade were painted in the same polychrome scheme using the moderate reddish brown on the newel posts, newel caps and the caps of the handrails while the upper and lower rails and the balusters were painted with the medium blue. Several fascia boards were painted moderate reddish brown and one was painted medium blue. Refer to the samples 201-9 and 10 in the appended Laboratory Data Sheets.

The mid-to-late 19th century staircase balustrades and fascia boards also were painted in the same reddish brown and medium blue polychrome scheme as the windows

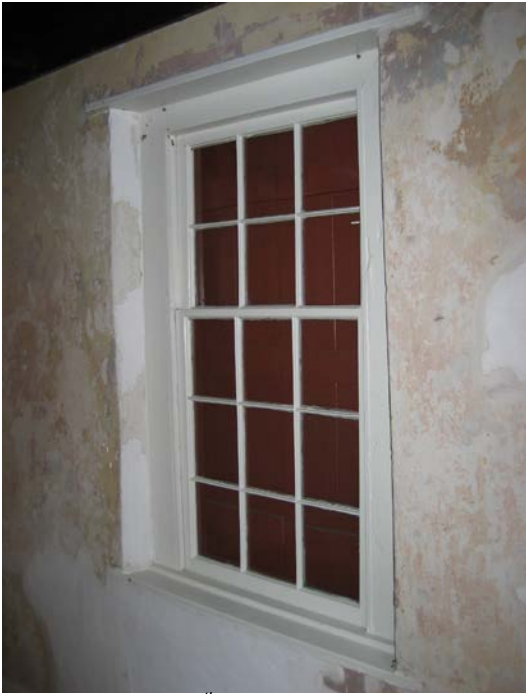
The oldest window sashes in the polychromed mid-to-late 19th century windows are later than the frames themselves. They were painted white originally. This white oil paint was also made primarily with zinc white pigment. The white paint on these older sashes shows up on the majority of the window frames, heads and sills two and sometimes three paint layers above the original moderate reddish brown and medium blue paints. This layer structure suggests that the sashes are approximately 20 years later than

Typical late 19th c. sashes in window 205

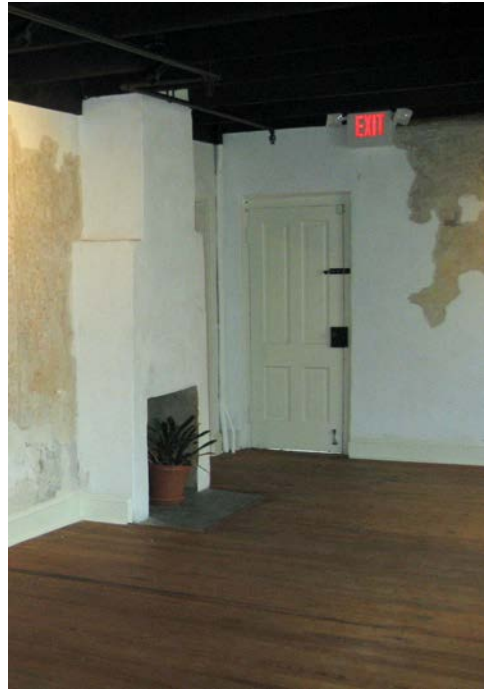
In addition, the frame of doorway 202-A shows a potential graining finish that has as its ground coat a white paint that also is made with zinc white. This zinc white paint may be contemporary with the zinc white paint used on the window sashes, suggesting that this doorway may also be late 19th century in origin.

Doorway 202A may also date to the same time as the typical late 19th c. window sashes

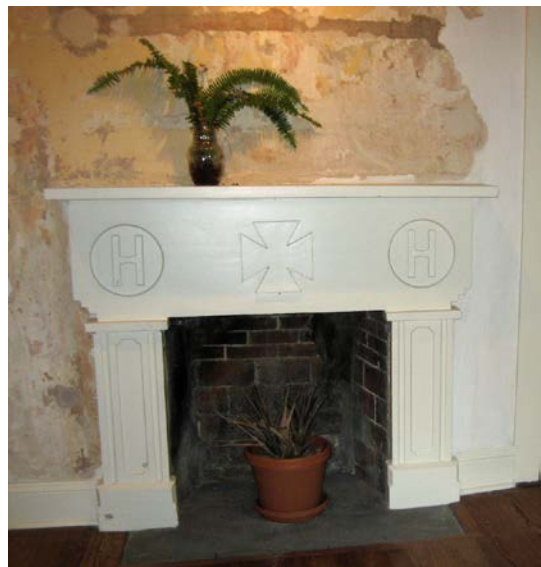
The Hardin period mantelpiece in Room 200 and the shelf in Room 204 have been stripped of all paint layers. However, there is trace evidence remaining on both of an original black resinous coating that suggests both features may have been marbled, which is an imitative painting practice typical of the mid and late 19th century for masonry mantels. Often the raised surfaces of such were embellished with gold bronze paint, but because of the paint removal, we could not ascertain whether or not this was done on the large mantelpiece, but it is a possibility.

With all of the architectural changes and alterations that have taken place at the Tovar House over such a lengthy period of time, it seems that it would be extremely difficult to interpret the entire house at a particular historically significant period. If the choice is made to interpret one or two period colorations and finishes, one might consider choosing to do so with only one room on each floor, i.e. one 18th c. room and one mid-to late 19th c. room. If this possibility is seriously considered, we would be pleased to assist in the process. Some of the obstacles that we could help sort out using the lab data may include (for example in Room 200): how to interpret the Hardin mantelpiece, whether or not the walls were papered when it was marbleized, and the color of the trim at this time, etc.

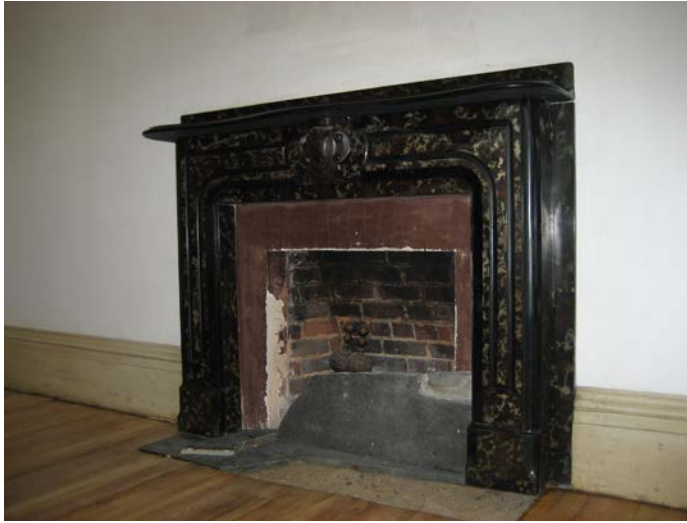
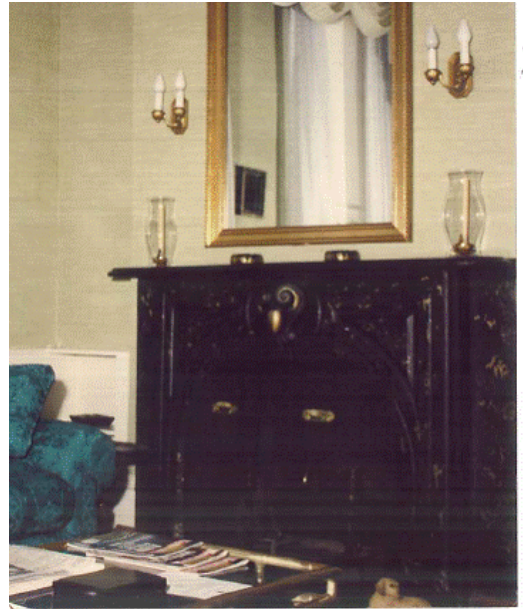
Two examples of late 19th c. marbled masonry mantelpieces. On the left: Hardman Farm in Helen, Georgia. On the right: the Visiting Flag Quarters at the Navy Yard in Washington, D.C.
